**FINAL INVESTIGATION REPORT ON
AIR TURN BACK INCIDENT DUE TO BIRD STRIKE TO
M/s GO AIRLINES (INDIA) LTD AIRBUS A320-214 AIRCRAFT
VT-GOS ON 21/06/2017 AT DELHI**

**GOVERNMENT OF INDIA
O/o, DIRECTOR AIR SAFETY, WESTERN REGION,
NEW INTEGRATED OPERATIONAL OFFICE COMPLEX,
SAHAR ROAD, VILE PARLE (EAST), MUMBAI-400099**

FINAL INVESTIGATION REPORT OF INCIDENT TO
M/s GO AIRLINES (INDIA) LTD AIRBUS A320-214 AIRCRAFT
VT-GOS ON 21/06/2017 AT DELHI

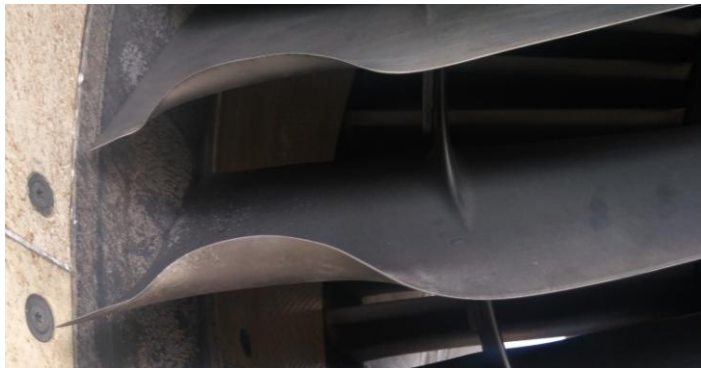
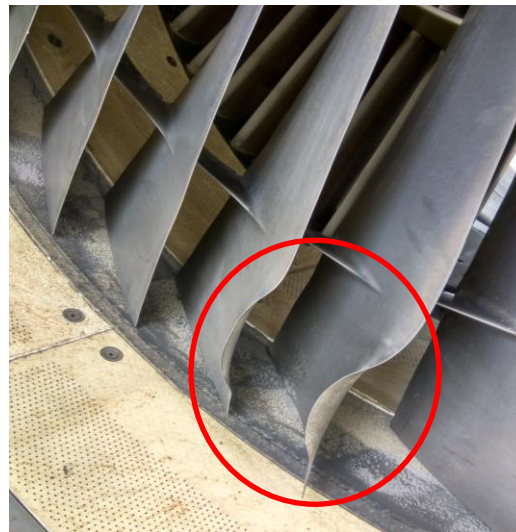
Tips of the leading edge of two fan blades no. 21 & 22 were damaged. Both the blades were distorted shingled.

Figure # 1
Damage to Blade no. 21 & 22

Figure # 2
Damage to Blade no. 21 & 22

- a) TSM for high engine vibration was followed and observed bird strike on Engine # 2 affecting fan blades # 21 & 22 with distortion and shingling. Rest all blades found normal.
- b) Engine bird strike inspection carried out. No core ingestion observed and no missing fan blade material.
- c) Fan blades # 21 & 22 replaced.
- d) High power run-up for vibration survey carried out, vibrations found within limits without noise or rumble.
- e) All related reports FADEC 1 & 2 test, Last Leg Report, post Engine # 1 & 2 ground run Post Flight Report found satisfactory.
- f) Engine # 1 & 2 MMCD & EMCD pop out checked found satisfactory.
- g) No related fault on Post Flight Report and Engine Warning Display status page normal.
- h) Boroscope Inspection to be carried out within 25 flight hours or 10 flight cycles (whichever comes first).

Boroscope Inspection of Engine # 2 was carried out on 22/06/2017 at 27592:02 hrs A/c TSN & 17565 A/c CSN and found satisfactory

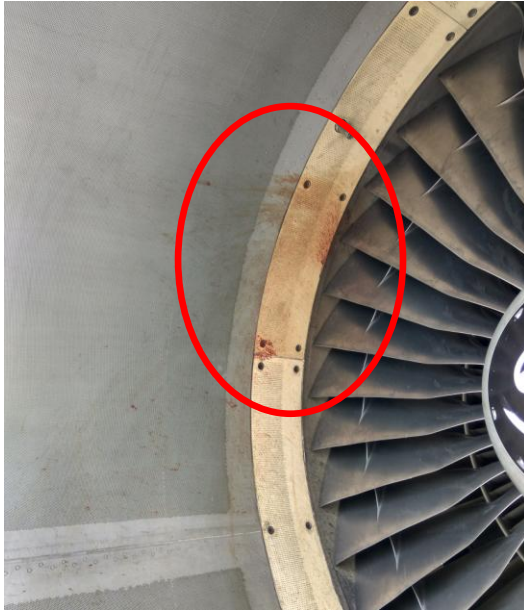
During physical inspection on arrival, the blood stains were observed spread on the acoustic panel of Engine # 2 between 7 O'clock till 11 O'clock positions (forward looking aft).

Figure # 3
Blood stains of bird

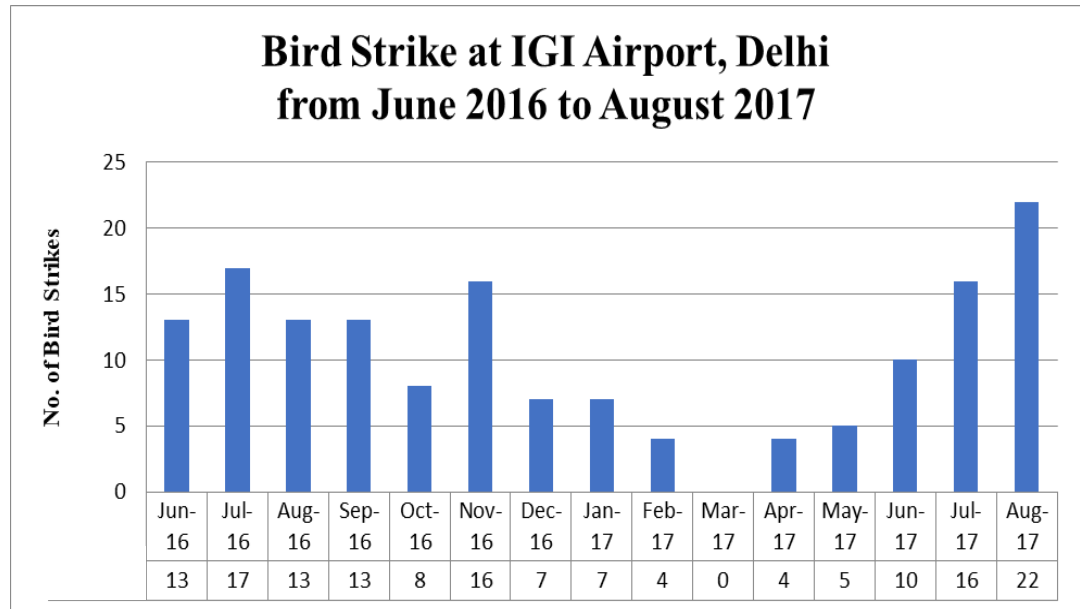
Though above-mentioned measures are in place to contain wildlife hazard it is seen that the number of bird strikes was increased substantially during the period from April 2017 – August 2017.

Figure # 5 No. of Bird Strikes reported at IGI Airport, Delhi

- Suitable corrective action to both crew members as deemed necessary by DGCA Hqrs in view of the above findings.
- DIAL may be advised to adhere to the programmes & procedures outlined in Aerodrome Manual of IGI Airport, Delhi considering the above findings.
- Effectiveness of the existing Wildlife Hazard Management plan may be ascertained and the Wildlife Hazard Management plan may be reviewed, if deemed necessary.

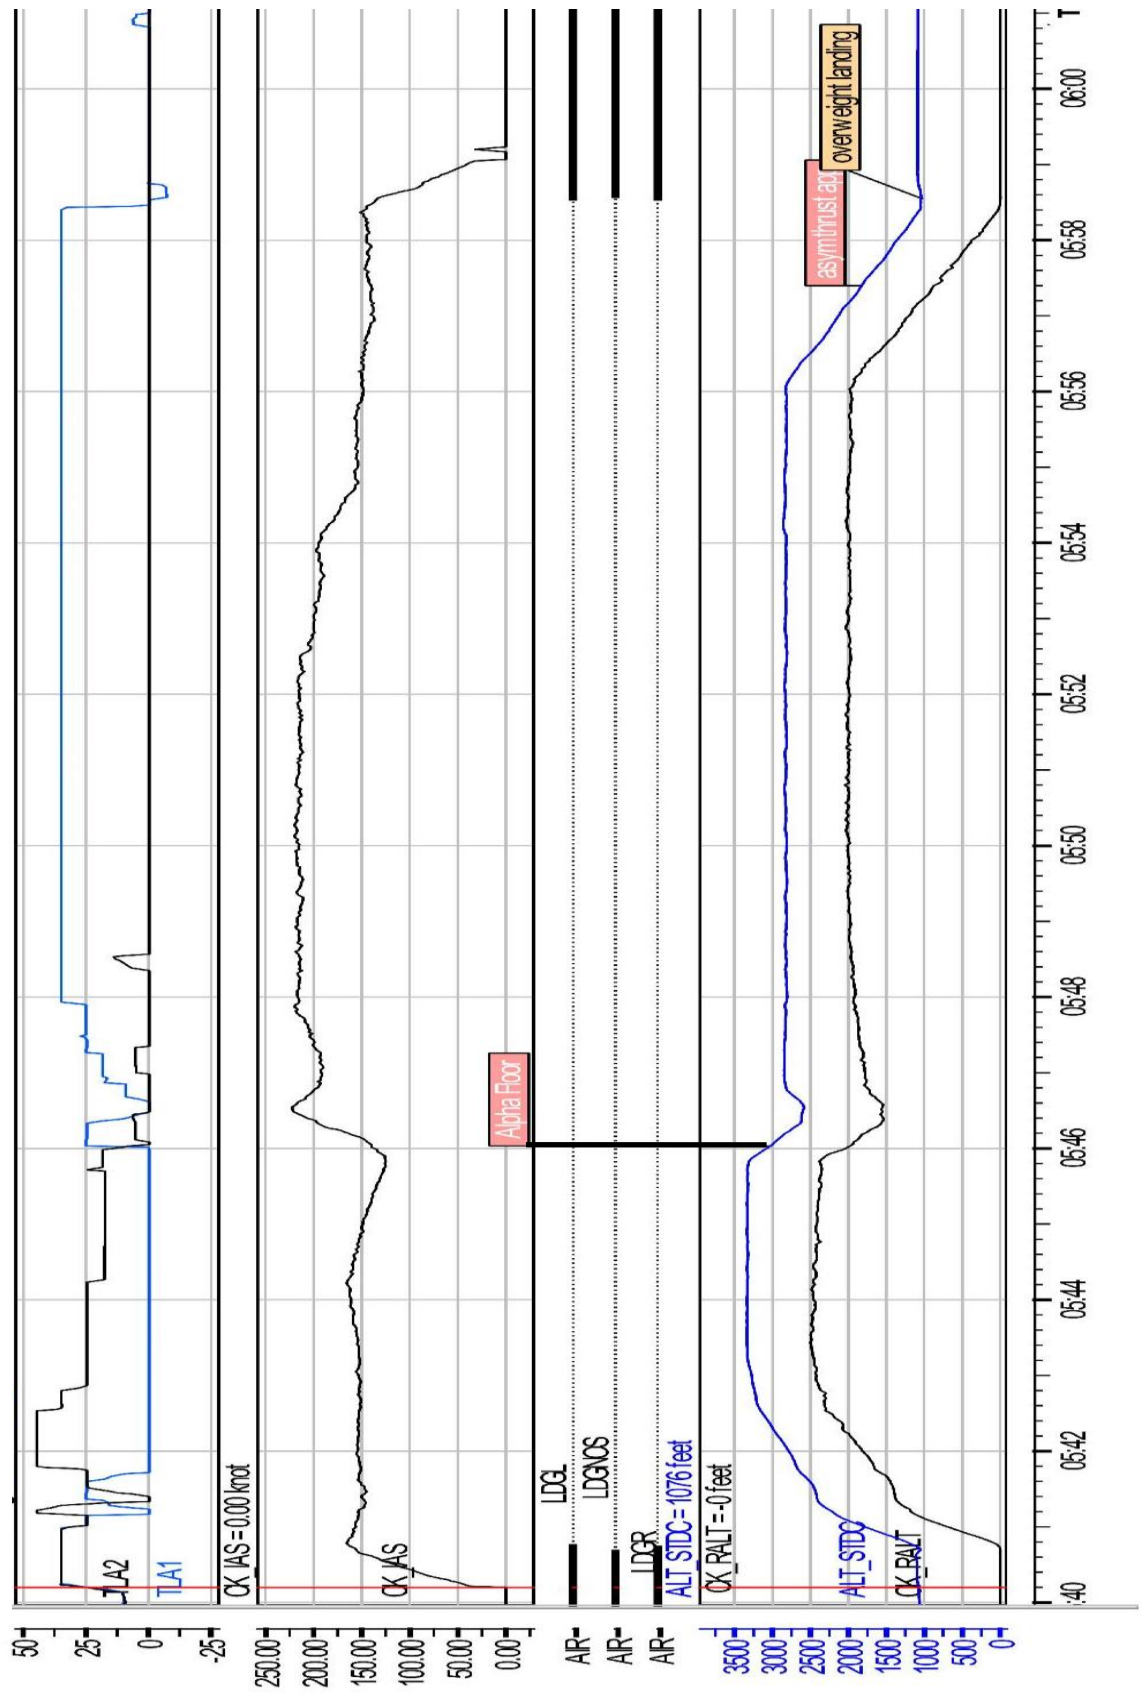
Figure # 6 Graphical representation of FDR data

06:01:41	Engine # 1 master off.
----	Crew did not complete the 'Take-off Checks' & 'After Take-off Checks'.

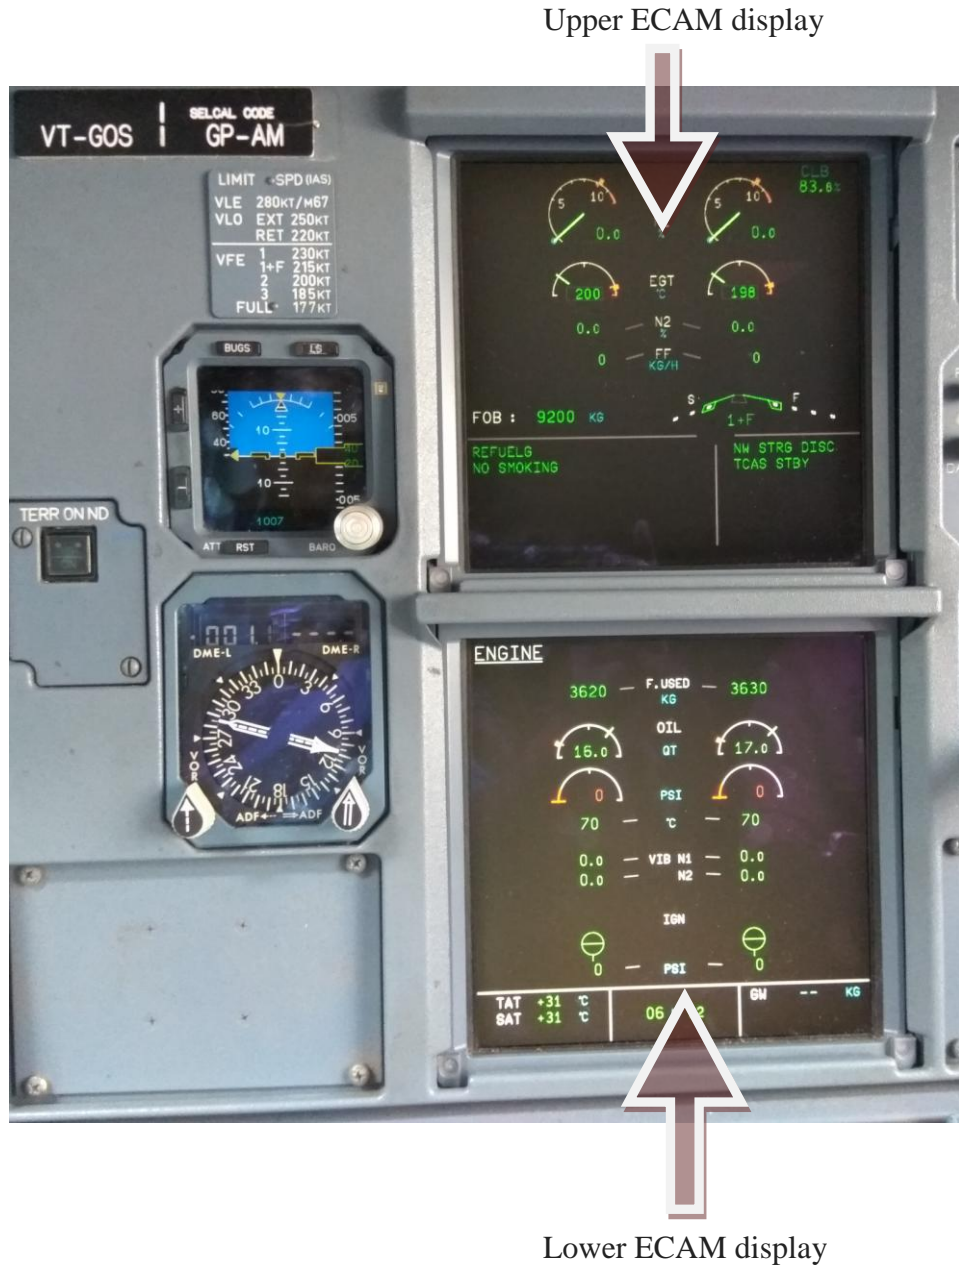
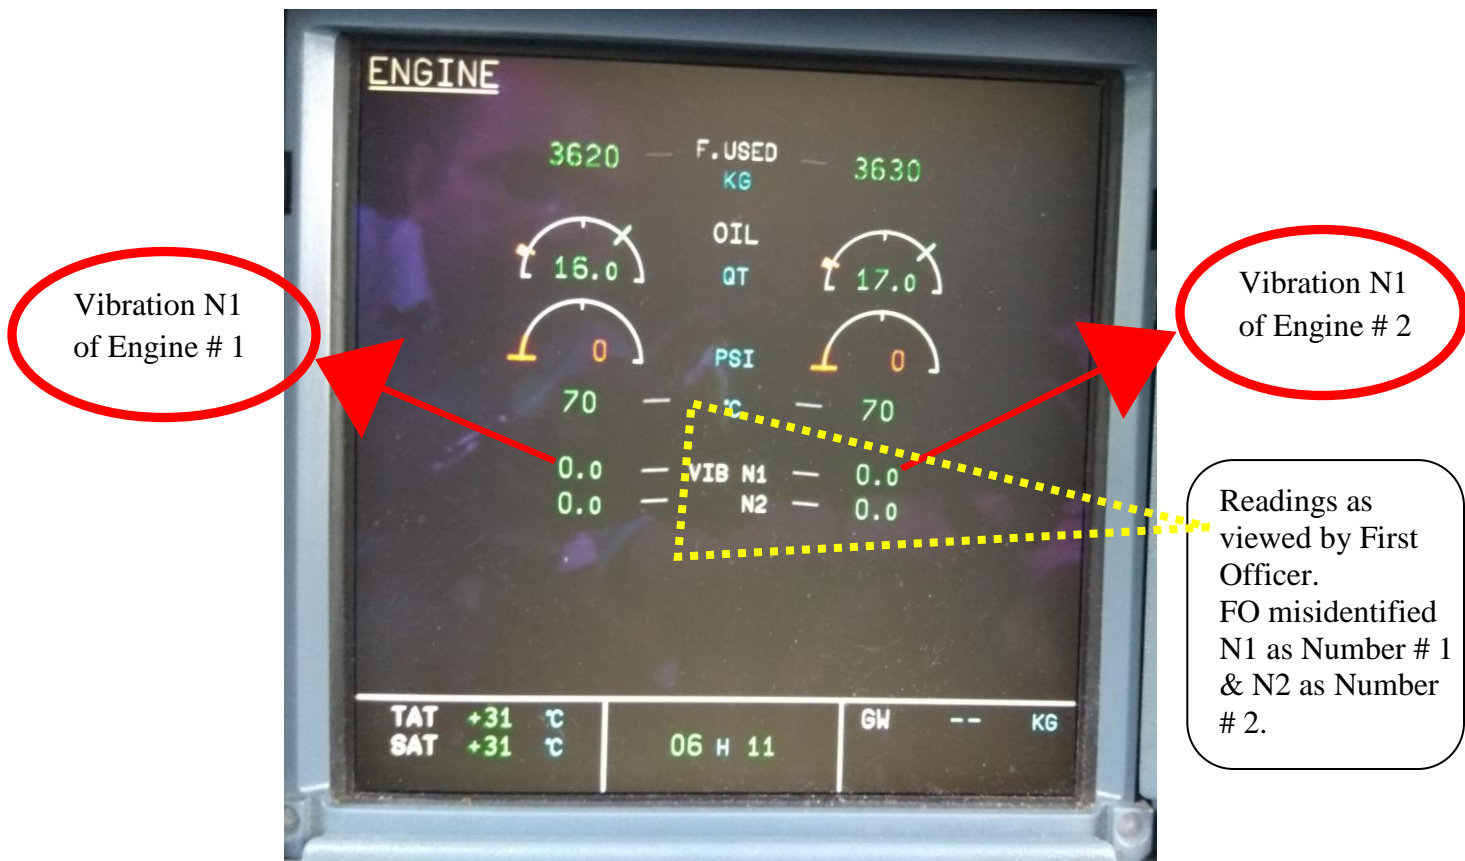
- On getting airborne, First Officer observed the Lower ECAM Advisory and N1 was incorrectly identified as Number # 1. However, vibration N1 in the Lower ECAM corresponds to fan vibration; and Left & Right positions of the readings corresponds to Number # 1 & Number # 2 engines respectively. The readings on left side of the vibration N1 were not catered for by the First Officer at this stage.

First Officer misinterpreted the reading vibration N1 of Engine # 2 as vibration of Engine # 1 and called out Number # 1 vibration out of limit. The situation was wrongly assessed by First Officer.

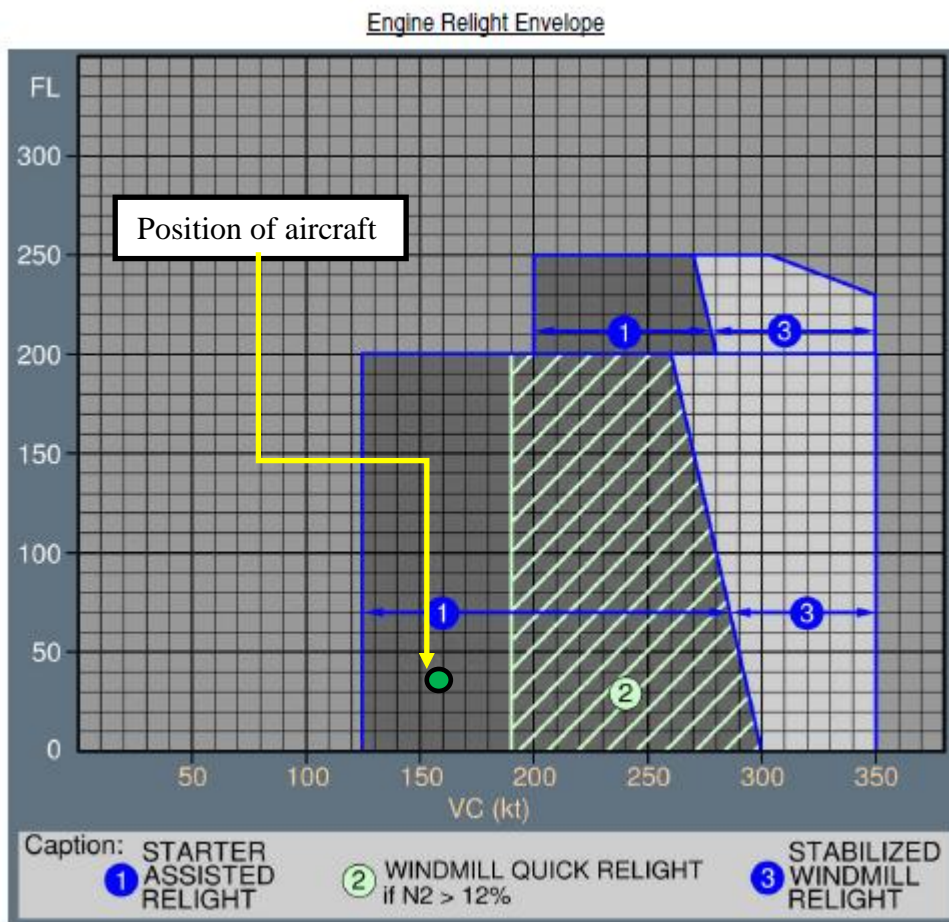
Figure # 9 Engine Relight Envelope

Crew realized the mistake of shutting down the wrong engine at 05:43:42 hrs and initiated starting of Engine # 1 at 05:43:46 hrs. The values pertaining to altitude, IAS and N2 of Engine # 1 at this stage are as follows:
