**Report of Hard Landing incident to M/s Jet Airways,
B-777-300 aircraft VT-JEQ at Hong Kong during the operation of
flight 9W-78(Delhi-Hong Kong)
of 27th April 2017**

**O/o Director Air Safety(NR),
Safdarjung Airport,
New Delhi-03**

Final Investigation Report of Hard Landing incident to M/s Jet Airways, B-777-300 aircraft VT-JEQ at Hong Kong during the operation of flight 9W-78(Delhi-Hong Kong) of 27th April 2017

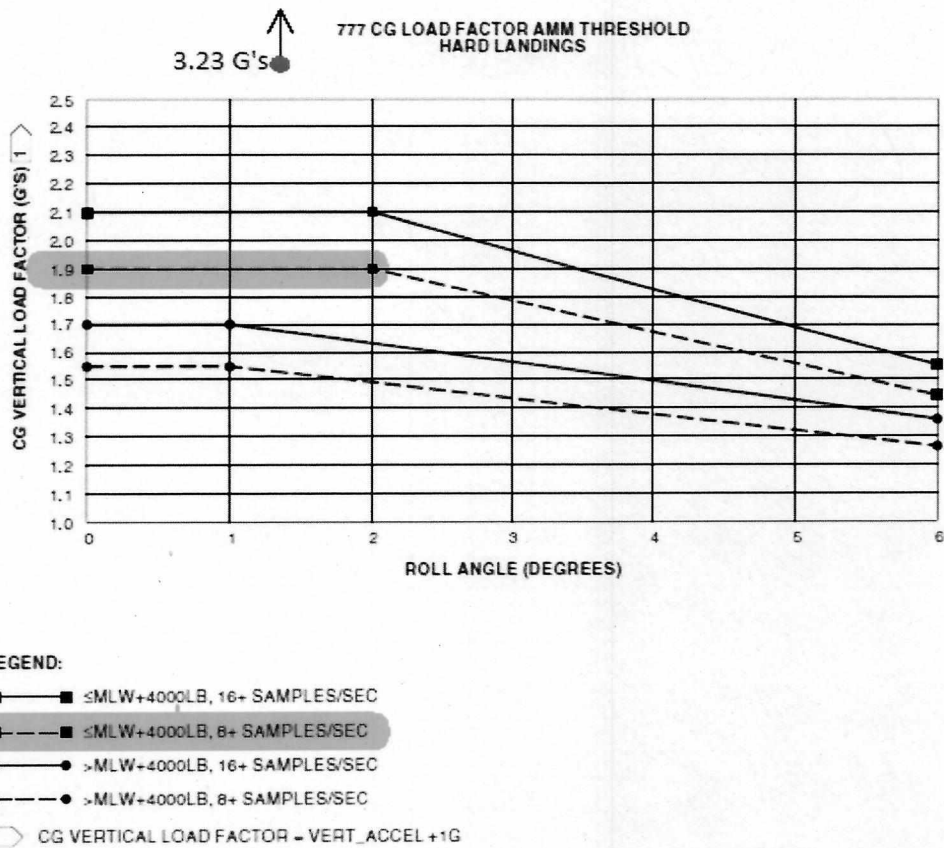
Fig.2 C.G Load factor Chart

- Based on the graphic above, the magnitude of vertical load factor translated to the CG was above the threshold for hard landings, indicating that the Phase IB inspection could not have been waived, regardless of the findings of the Phase IA inspection. Note that a Phase IA inspection is not required unless the flight crew reported a hard landing. The inspections would be at the airline's discretion.

- **Conclusion**
- If the subject landing had been reported as "hard" by the flight crew, Phase IA and IB inspections would have been required prior to the next flight. If flight data had been available, an evaluation could have been performed to determine if the Phase IB inspection could be waived. Analysis of this landing indicates that the vertical acceleration experienced was **above the AMM threshold, indicating that the Phase IB inspection could not have been waived, regardless of the findings of the Phase IA inspection**, if the pilot had called the landing hard. If using data alone, without the pilot's call, the inspections are at the airline's discretion. At touchdown, the closure rate of the main landing gear with the runway was 8.1 feet/second

- (assuming a zero runway slope) which is below the design limit of the gear. Boeing maintains that the flight crew's judgment is the most reliable criterion to use for determining if a hard landing has occurred. Data alone are insufficient to make this determination.

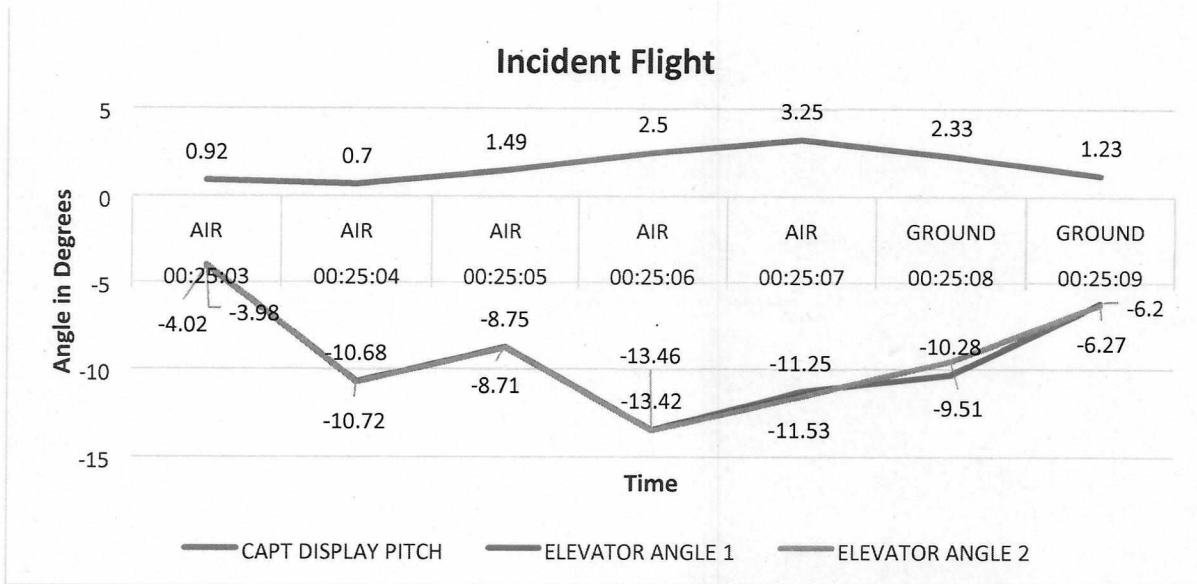
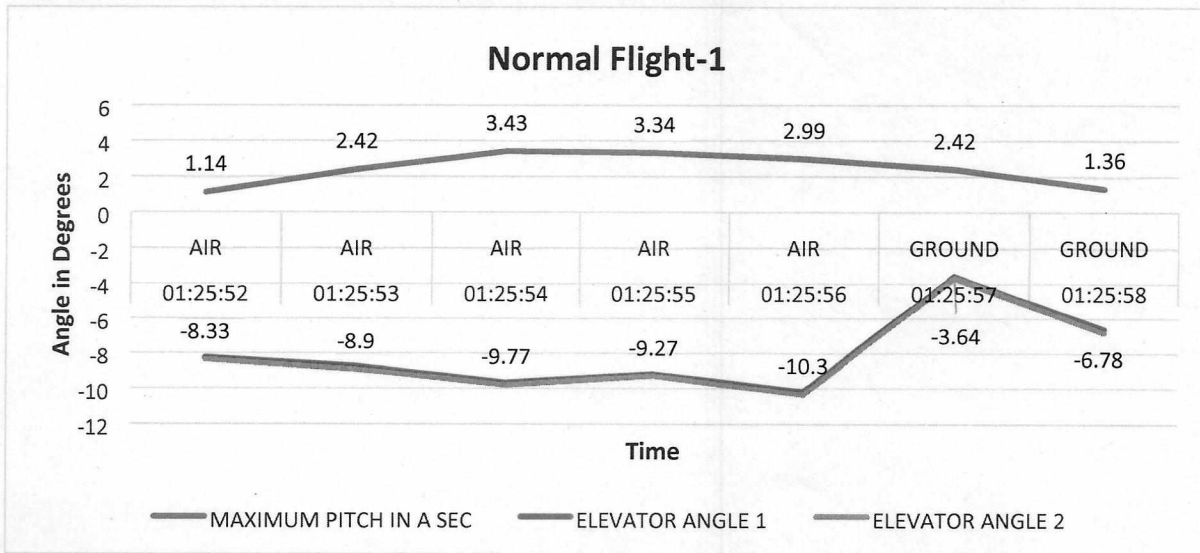
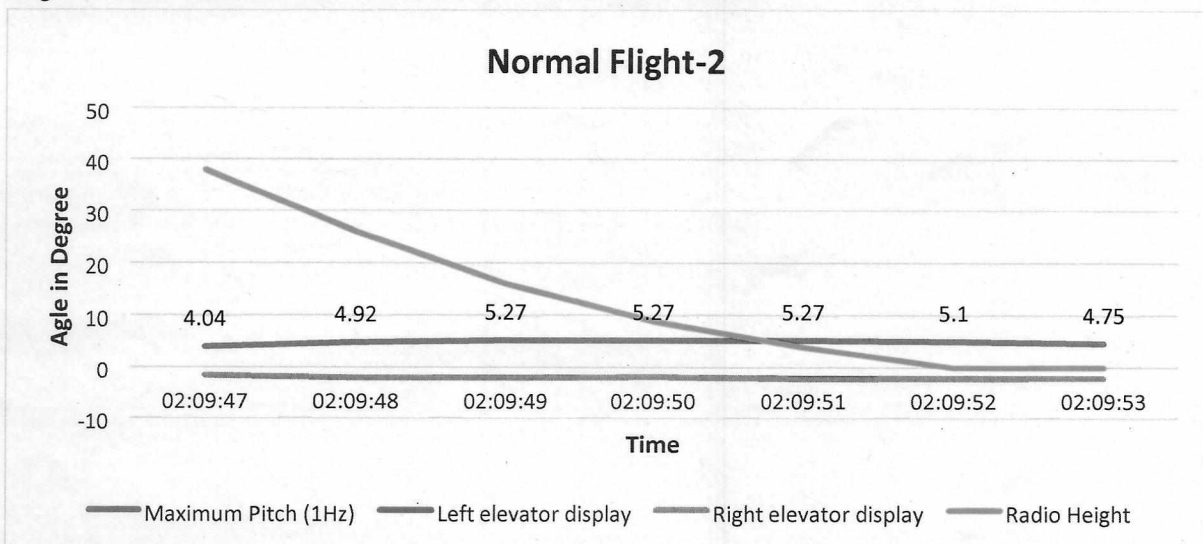
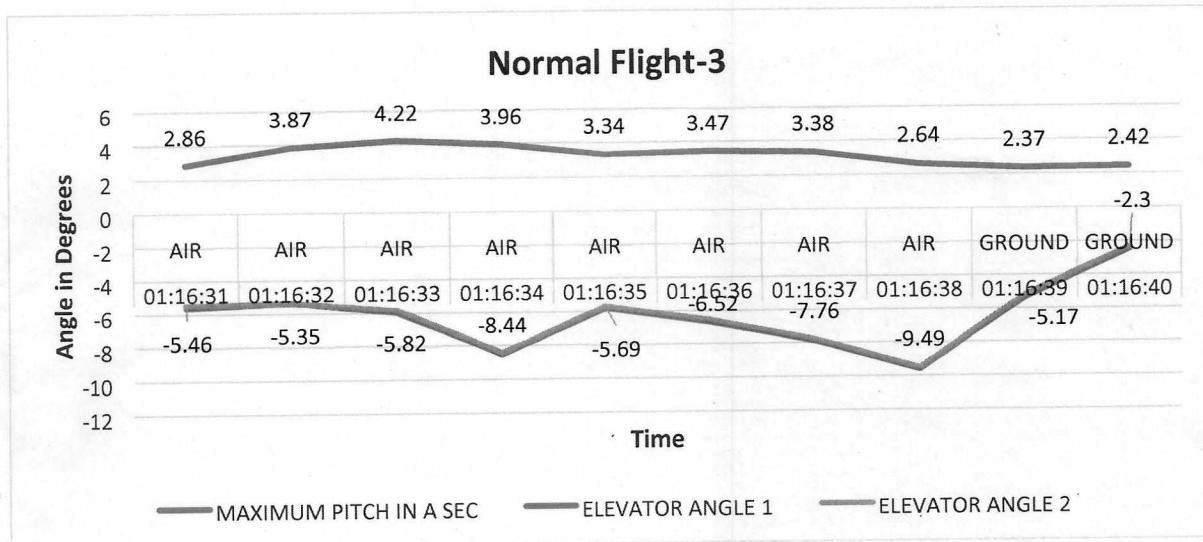
The pitch angle variations along with elevator deflection in the incident flight was compared with three other normal landings at Honkong as detailed below:

From the comparison it is evident that there was large variation in the elevator deflection. Initially during the flare, he put the nose down and then pulled up, and this process continued till touch down. During the incident flight the pitch attitude of 3.25 degree was attained just before touch down.

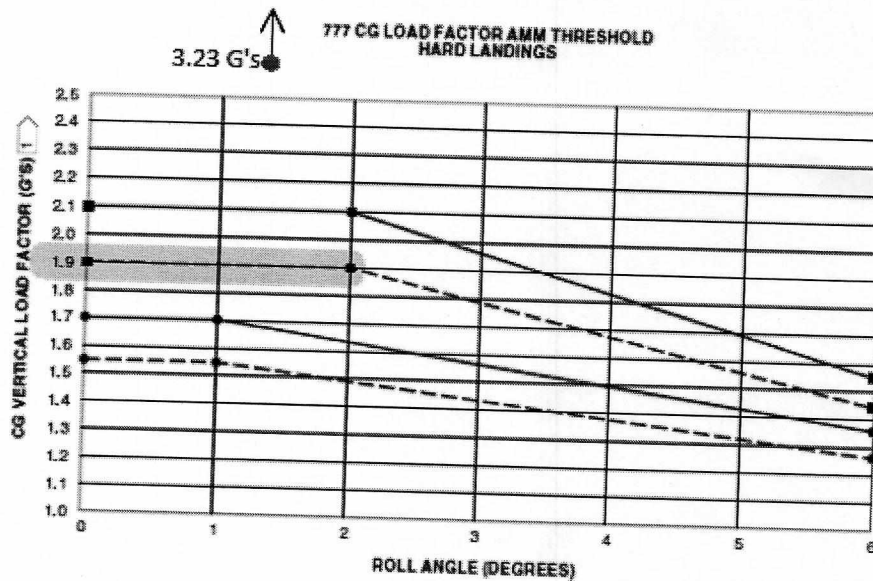
Section 05-51-01, Chapter (1)(F) outlines the inspection logic, which is also presented in flowchart format (AMM Figure 201). If the flight crew reported a hard landing, the Phase IA and Phase IB inspections would have been required prior to the next flight. If flight data had been available, then it is advised to check the vertical load factor and roll angle against the 777 CG Load Factor AMM threshold. If the data indicate a vertical load factor below the threshold, and no damage is found during the Phase IA inspection, the Phase IB inspection may be waived. The graphic below shows the AMM vertical load factor threshold, with the maximum vertical load factor and roll angle at touchdown for the event landing overlaid on the graphic (red dot symbol). The magnitude of the vertical load factor was off the scale of the graphic. For this comparison, the 8+ sps curve must be used along with the appropriate touchdown weight (yellow highlight).
