FINAL REPORT ON INCIDENT TO M/S FALCON AVIATION ACADEMY
CESSANA -152 AIRCRAFT VT-PTB AT FAIZABAD ON 04.03.2015

| 1. Aircraft Type | : CESSNA 152 |
| Registration | : VT - PTB |
| 13. Type of incident | : Abnormal Runway Contact |

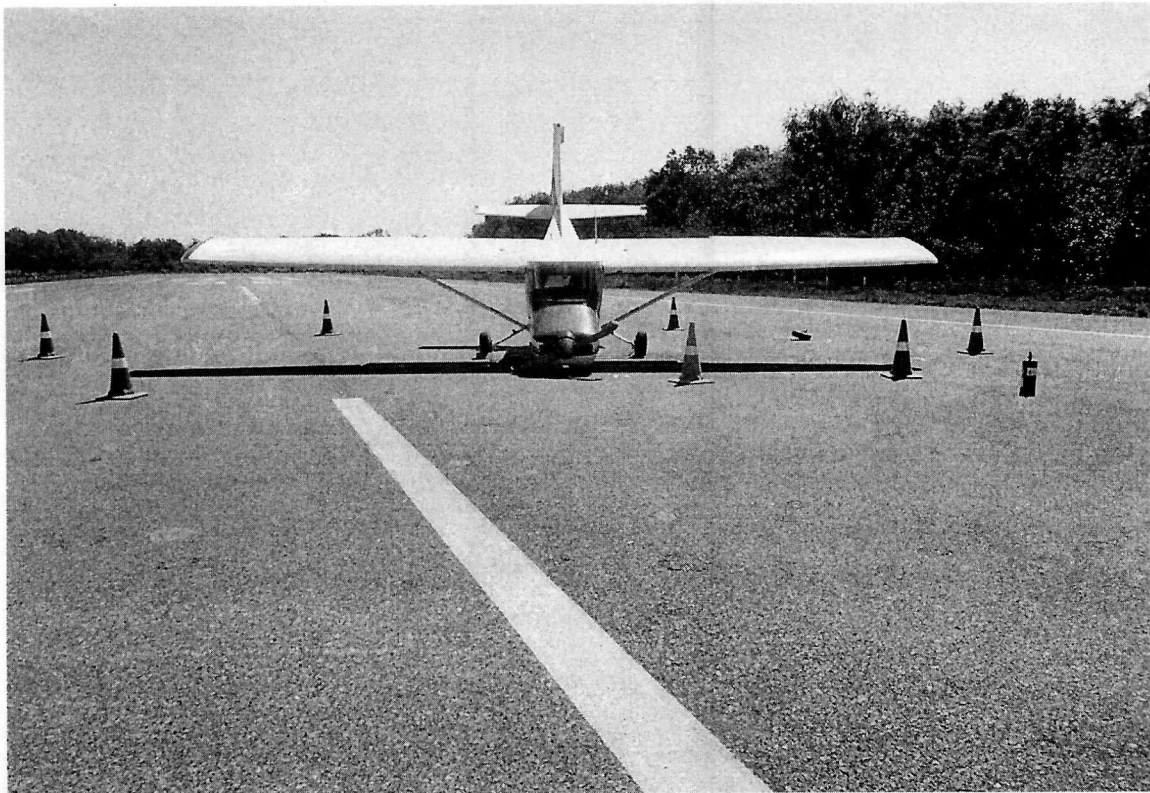
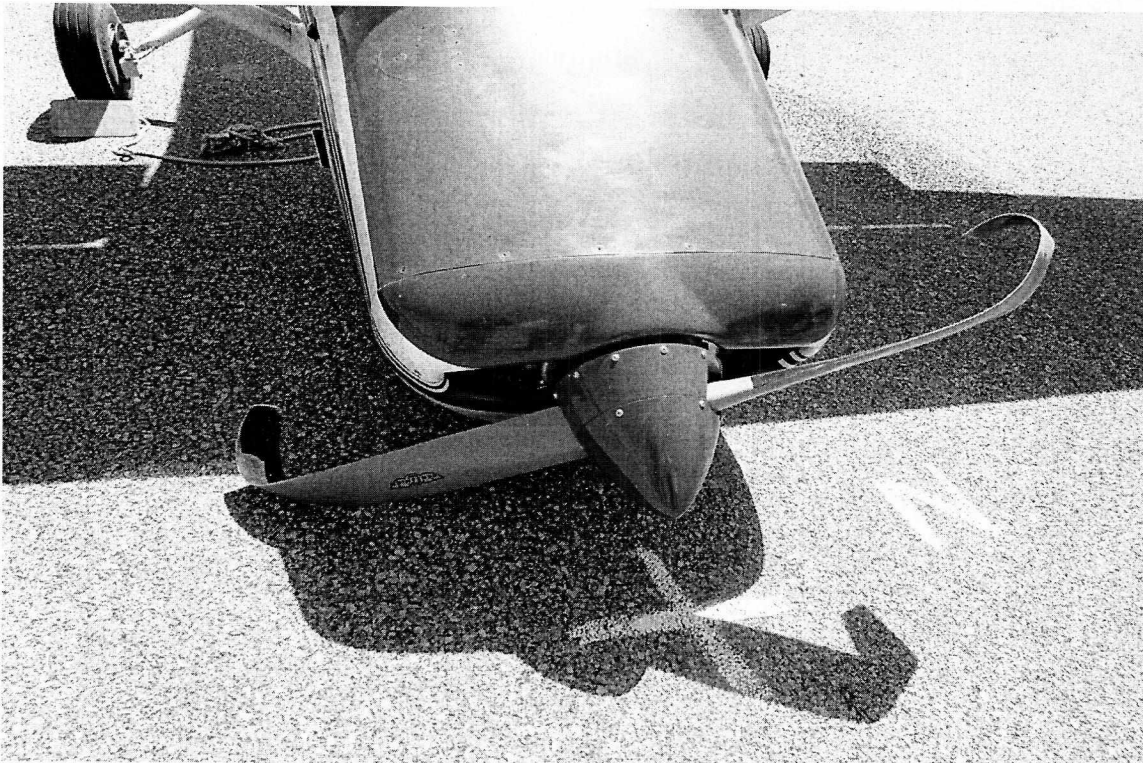
Due to the impact, the nose gear sheared off from the fork attachment fitting. As per CFI, fuel was found dripping from the left side of the wing fuel tank vent on the runway.

On examination of the wreckage and runway at the site, the aircraft was found to be lying on its nose. Traces of fuel spillage were found on the runway under the left wing.

- i. Both the Propeller blades found bent inwards.
- ii. Nose oleo strut was found broken from the fork attachment fitting
- iii. Shimmy dampener found detached from the nose gear fitting
- iv. Both steering rods (LH & RH) found bent
- v. Engine mount found broken

- a. Instructions to be issued by the flying club for all the trainee pilots to come out of the aircraft immediately after incident.
- b. A onetime inspection to measure the dimensions of axle tube and of the bearing of the nose wheel of the entire fleet of the flying club.
