**FINAL INVESTIGATION REPORT ON SERIOUS  
INCIDENT TO M/s SPICEJET LTD. BOMBARDIER  
DHC – 8 – 402 (Q-400) AIRCRAFT VT-SUL AT IGI  
AIRPORT, DELHI ON 08.11.2017**

**AIRCRAFT ACCIDENT INVESTIGATION BUREAU**

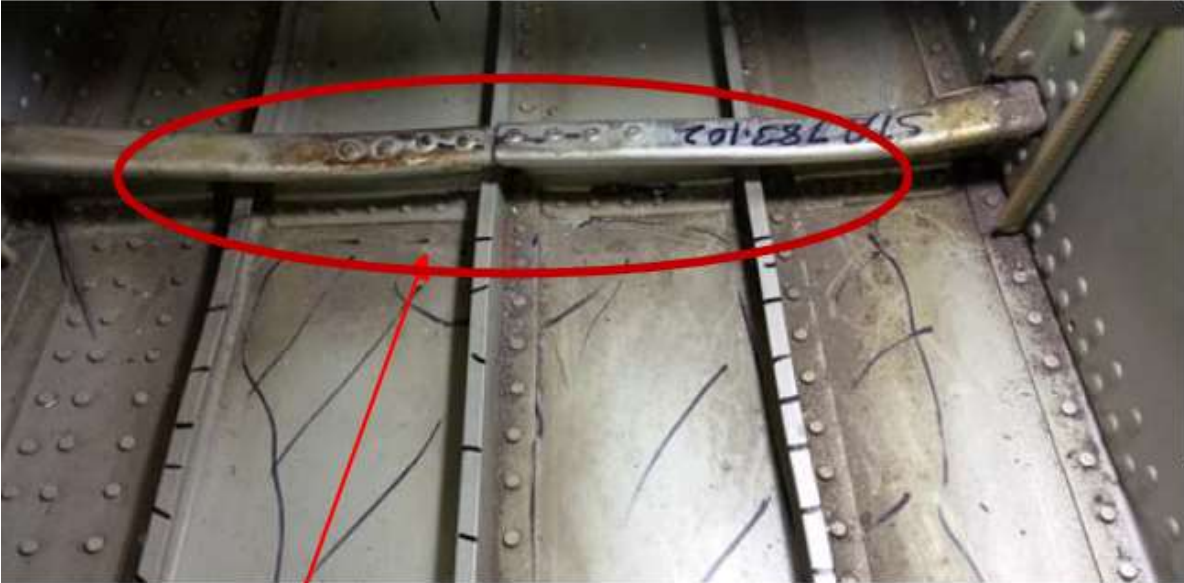
**Buckling damage at Frame X783.602**

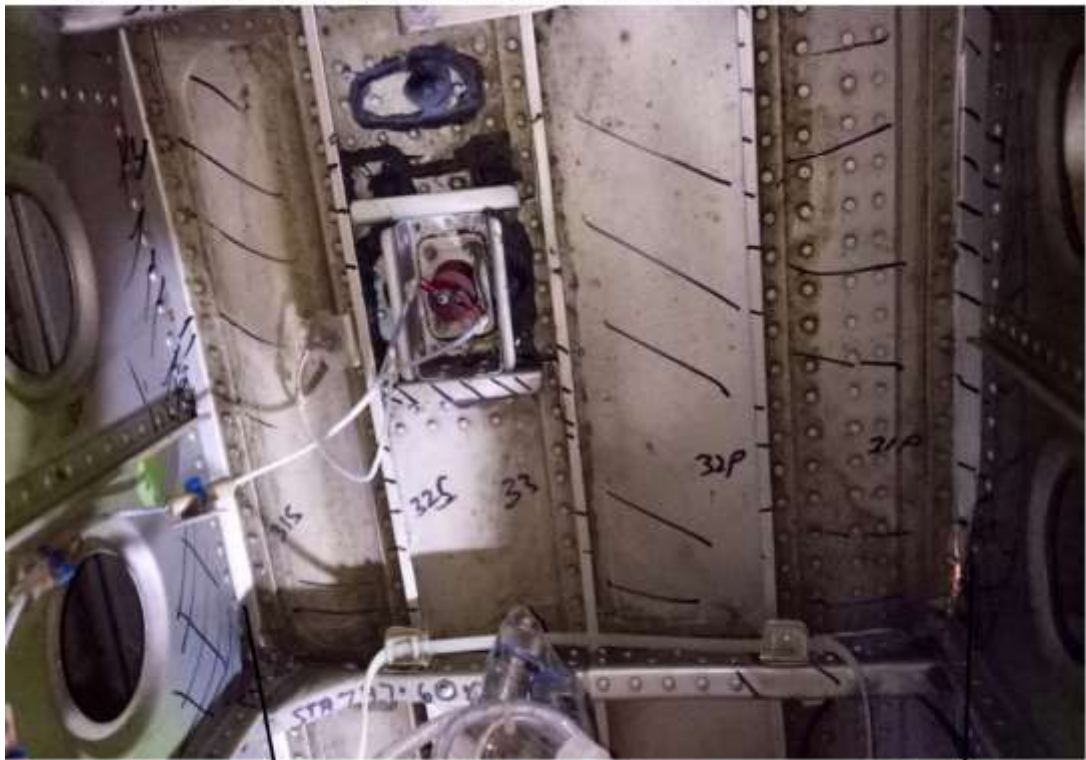
**Skin and Stringer damage between Station 747.602 & 763.602**

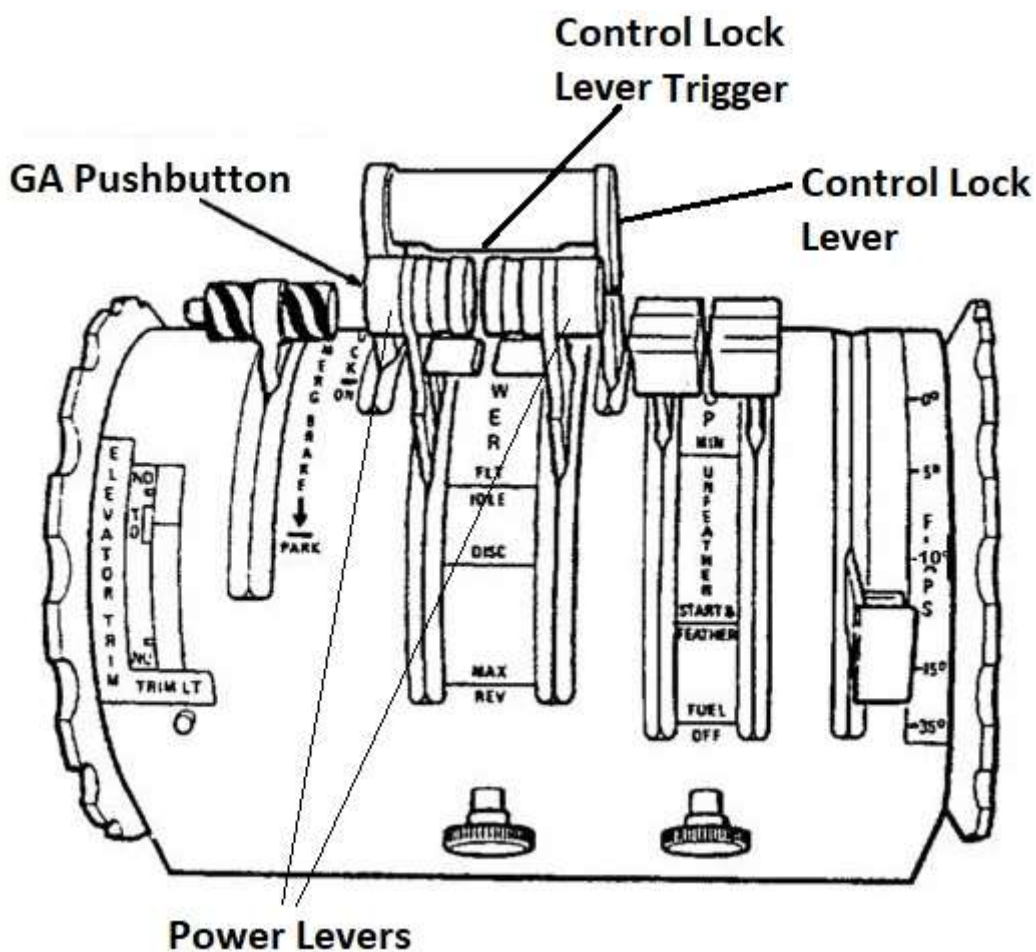
Go-Around switches are pushbuttons situated on both sides (of #1 & #2 power levers) of the power lever handle. The control lock Lever can be locked in two positions i.e. OFF & ON. The control lock lever cannot be moved unless the control lock lever trigger is pressed.

If the throttle lever is not properly handled, the GA button may be pressed by the thumb.
