**FINAL INVESTIGATION REPORT ON SERIOUS
INCIDENT TO M/S SPICEJET BOMBARDIER
DHC8-400 AIRCRAFT VT-SUM AT NAGPUR ON
24.11.2017**

**GOVERNMENT OF INDIA
MINISTRY OF CIVIL AVIATION
AIRCRAFT ACCIDENT INVESTIGATION BUREAU**

**INVESTIGATION REPORT ON SERIOUS INCIDENT TO M/S SPICEJET
BOMBARDIER DHC8-400 AIRCRAFT VT-SUM AT NAGPUR ON 24.11.2017.**

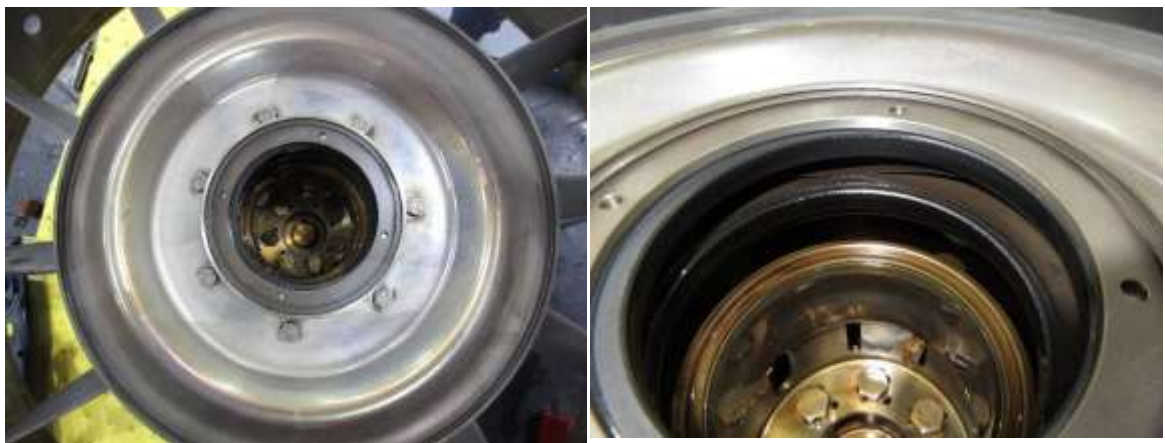
The o-rings of the RGB (Reduction Gear Box) main oil filter housing were found to be cut. The magnetic Chip Detectors of the TM Module, RGB Module and A/C Generator were found with little metal pick up.

The oil screen at the Inter Compressor Case was found to have carbon like material, which became powder when handled.

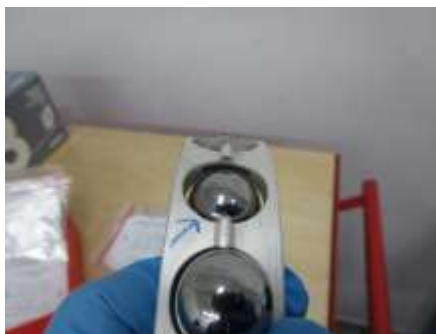
No. 1 Brg. - Flaking at cage

No.	DESCRIPTION	REMARK
1.	BEARING NO.1	FLAKING FOUND ON CAGE POCKET.
3.	BEARING NO.2.5	DENT ON ROLLERS ELEMENT, CAN BE FELT WITH DESIGNATED SCRIBER.
4.	BEARING NO.3	FLAKING FOUND ON INNER DIAMETER OF CAGE AND CAGE POCKET.
5.	BEARING NO.4	CORROSION FOUND ON 30 PERCENT OF SURFACE AREA 1. FRETTING CORROSTION FOUND ON INNER RING

In the present case, the #1, #2.5, #3 and #4 bearings had all suffered some form of damage resulting in generation of metal chips. The damage could be attributed to a combination of lack of lubrication as well as vibrations due to imbalance seen in the LPC.

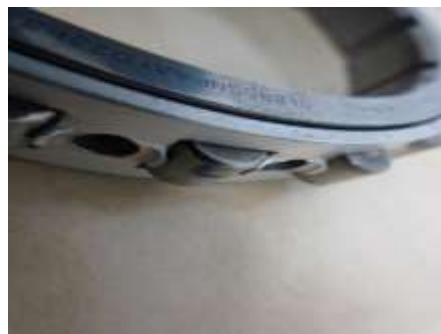
No.2.5 Brg. Dents on Roller Elements

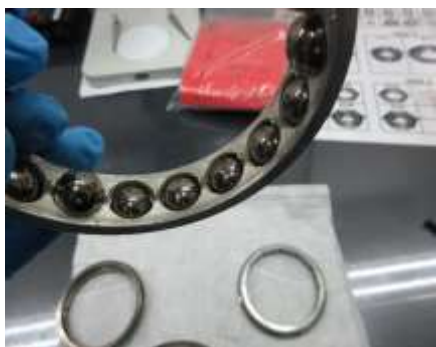
No.3 Brg. -Flaking of inner diameter of cage.

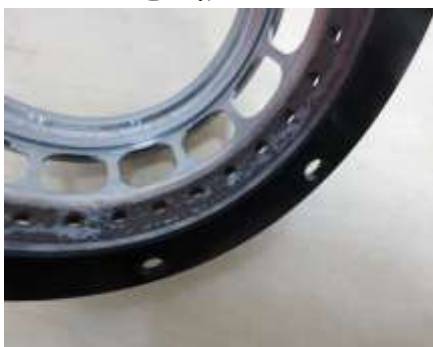
No.4 Brg: Corrosion on more than 30% of Area 1

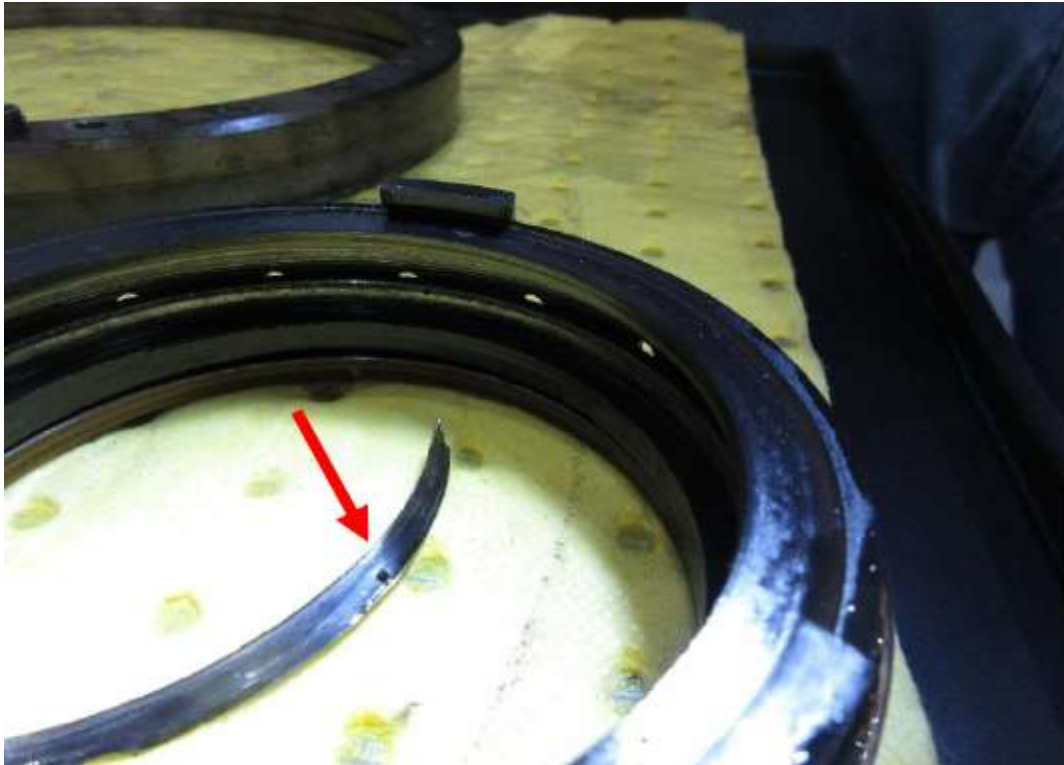
Wave spring of No. 3 bearing carbon seal assembly had broken

To conclude, the aircraft incident is attributed to the #3 Bearing Carbon Seal that had failed in service and caused oil to leak into the gas path. This

caused oil fumes to be released into the aircraft cabin through the Bleed Off Valves. Eventually enough oil was lost to cause the engine to lose oil pressure and trigger the Low Oil Pressure indication in the cockpit.

The incident occurred as No. 3 Bearing Carbon Seal failed in service resulting in oil leak into the gas path causing oil fumes getting into the aircraft cabin through the Bleed Off Valves.

Service Bulletin 35341 replaces the #3 Brg. carbon seal with one made from a carbon grade that is more resistant to high temperatures and humid environments. Similarly, the SB No. 35342R1 requires that No. 2.5 bearing seal be replaced with new one that has an increased minimum spring load to prevent potential spinning of the air/oil bearing seal ring.
