**FINAL INVESTIGATION REPORT ON SERIOUS  
INCIDENT TO M/s SPICEJET LTD. BOMBARDIER  
DHC – 8 – 402 (Q-400) AIRCRAFT VT-SUL AT IGI  
AIRPORT, DELHI ON 08.11.2017**

**AIRCRAFT ACCIDENT INVESTIGATION BUREAU**

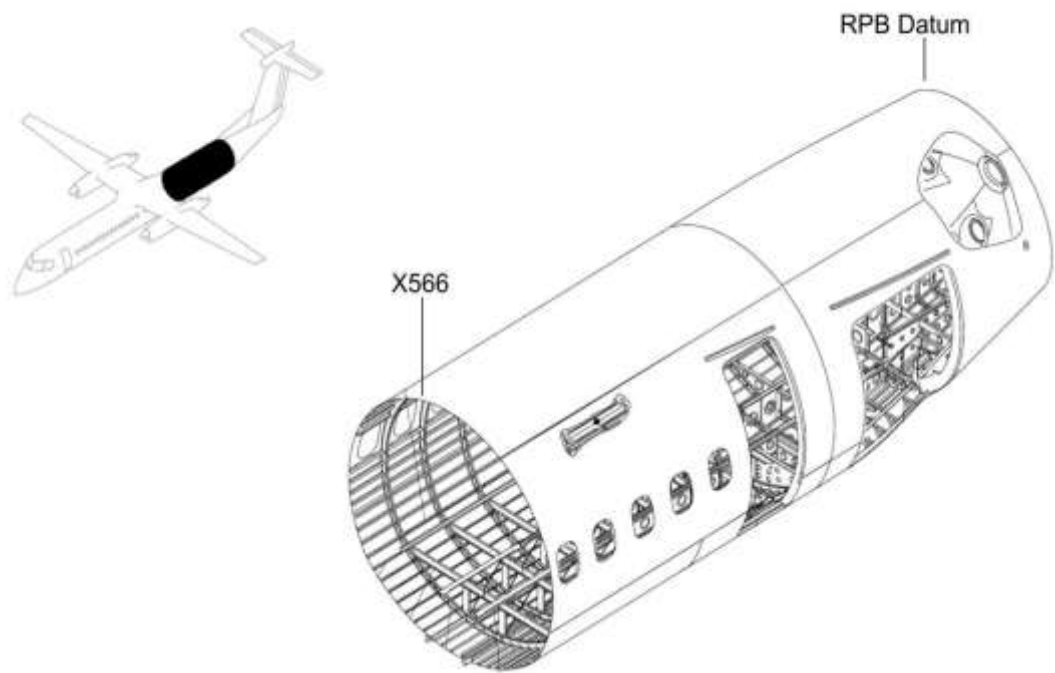
***Aft Centre Fuselage Section***

- Lower surface skin received heavy scrape marks, cracks, buckles, tears and crease damages between cross section 697.5 to 801 and between stringers 29P to 29S.
